Lead-Based Paint Inspection

Site: 508 Gartland Ave., Sandusky, OH 44870

**Prepared for
Erie Metropolitan Housing Authority
322 Warren Street
Sandusky, OH 44870**

**HazCorp Project No. 2022-137
March 25, 2025**

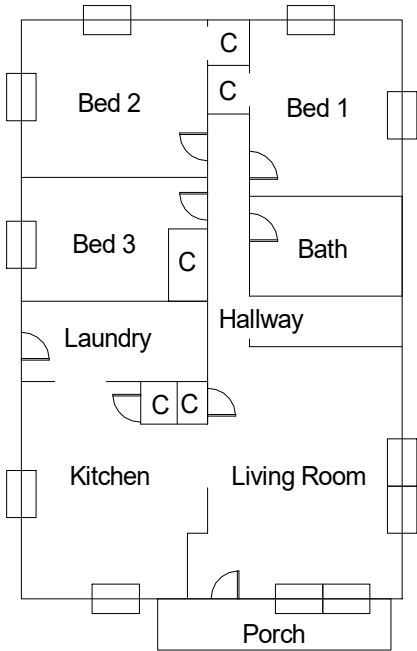
Figure 1

**Site Map -
508 Gartland Ave.,
Sandusky, OH 44870**
