Lead-Based Paint Inspection

**Site: Bayshore Towers Apartments
128 Perry Street, Sandusky, OH 44870**

**Prepared for
Erie Metropolitan Housing Authority
322 Warren Street
Sandusky, OH 44870**

**HazCorp Project No. 2021-243
August 6, 2021**

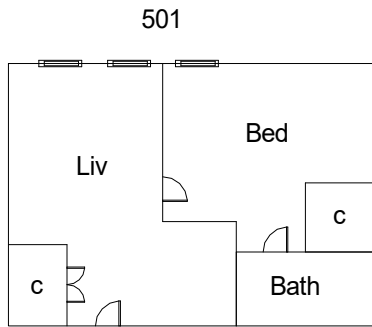
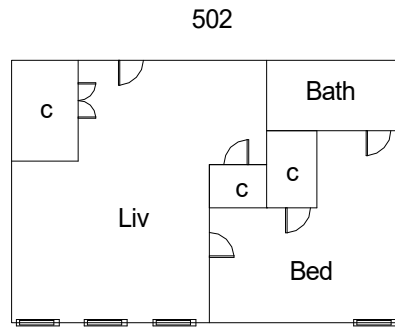
Figure 2	HazCorp Environmental Services, Inc.
	Drawn By: CDL
Site Map - Units 501,502,403,306,204 Bayshore Towers 128 Perry St, Sandusky, OH 44870

During the survey certain information was recorded for each component tested. This information includes component name, substrate, condition of paint, color of paint, component location (building number, unit number, floor number, room identifier and side of room) and lead content. The side of each room is assigned a letter A, B, C or D. In each room the wall closest to Perry Street was assigned the letter A, with remaining walls assigned B, C, and D in a clockwise manner.
